Fact Sheet - Fouling Growths

Pipeline Fouling Growths: A difficult and common problem

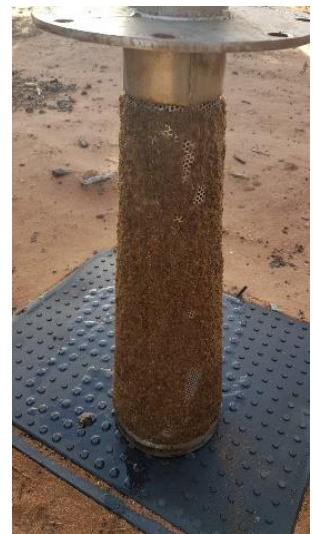
Bryozoan growth totally blocking a filter.

It is also extremely important to ensure that filters are properly maintained and regularly cleaned. Self-flushing systems are the most effective. These must be regularly checked to ensure that the velocity of water providing the flushing is enough to effectively clean out the blockages. It is common for growths to only be partially removed and over time the back flushing then becomes increasingly ineffective.

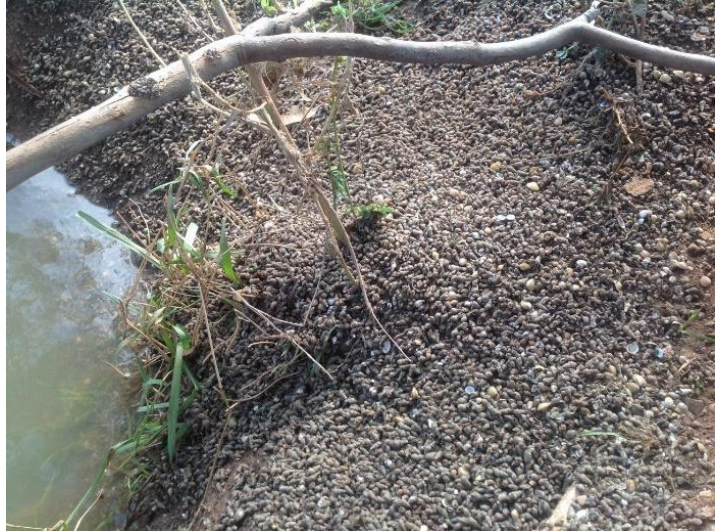
Shells flushed from a CIT main line during maintenance operations.

The problem is a huge challenge for CIT. The fouling growths line the nearly 500 km of pipework, effectively reducing the diameter and therefore restricting flow. The cost of pumping is then increased, as it is for maintenance which is continuous and ongoing. Pipelines are regularly flushed to remove as much of these growths as possible. This must be done when water
